HO-1095

B. & O. Railroad Realignment

Patapsco Valley State Park, McKeldin Area, east of Marriottsville Road

Maryland Inventory of Historic Properties Form

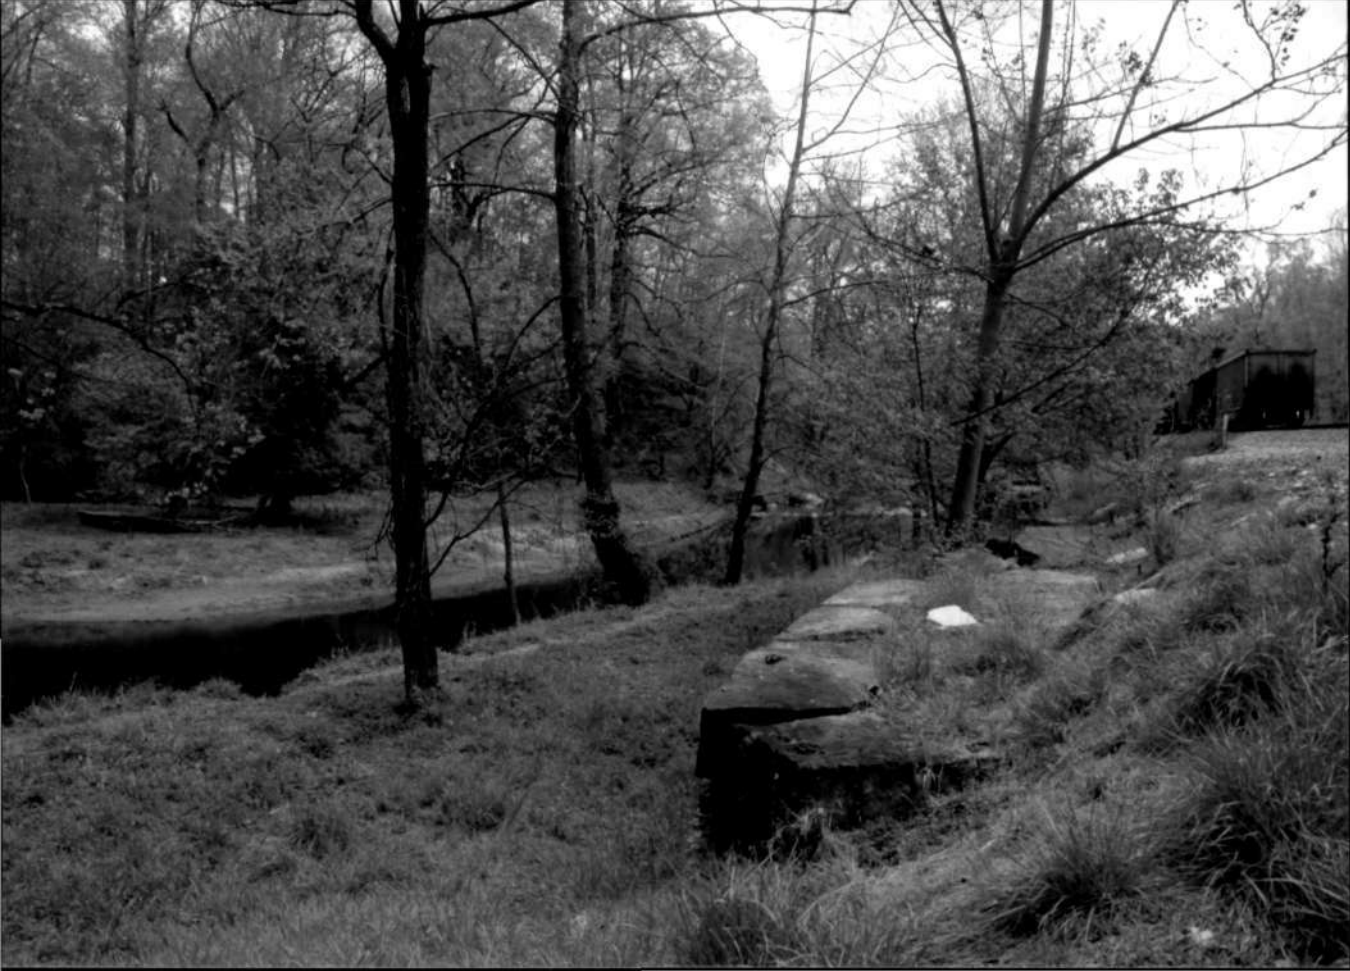
HO-1095_2012-04-24_01
Diverted river, retaining wall, & realigned
track, vw. southeast from northwest end

Diverted river, retaining wall, & realigned
1 of 6 track, vw. southeast from
northwest end

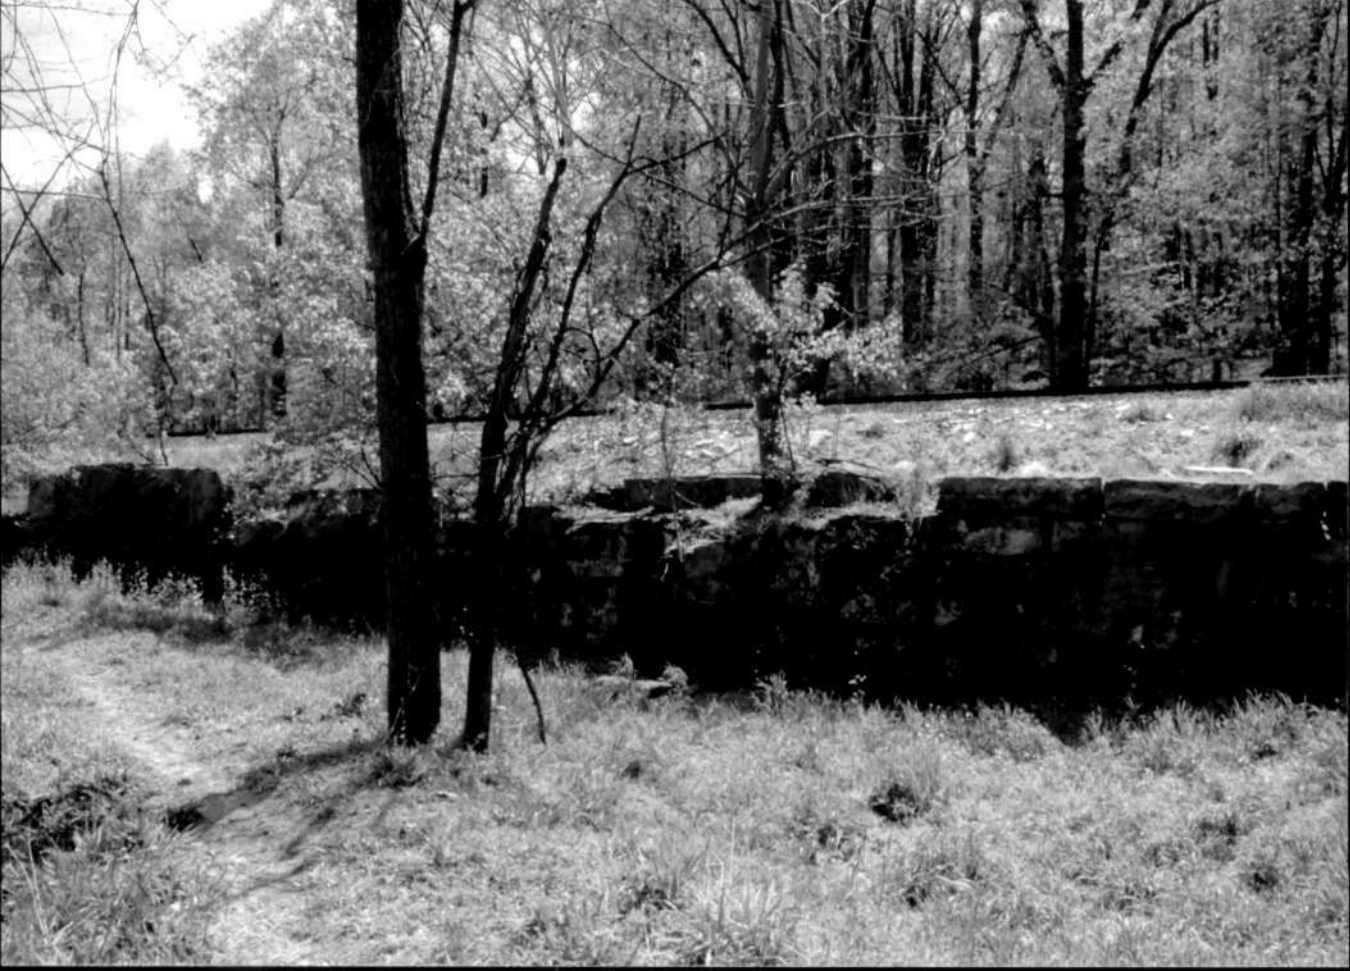
2 of 6

The present roadbed runs in a straight line northwest to southeast between either end of the old roadbed; this section of track is approximately .25 miles long and is built on a high embankment. At the northeastern end of the present roadbed is a low stone retaining wall that parallels the tracks and is set about 15 feet from them. The ends of the wall are angled away from the tracks. The center of the wall consists of very large blocks of granite rubble that are roughly squared and stacked without any mortar. The northwest end of the wall has mostly collapsed, but the southeast end is intact. It is built of medium-sized granite ashlar set in mortar, and this wall passes behind the larger rubble stones. The current river runs southwest toward this wall then turns to the southeast short of the wall and parallels the tracks for about .15 miles, passing through a man-made waterfall (McKeldin Falls) and into a broad shallows, where the river then turns to the north, away from the tracks.

HO-1095_2012-04-24_02
Retaining wall, vw. southeast

Retaining wall, vw. southeast

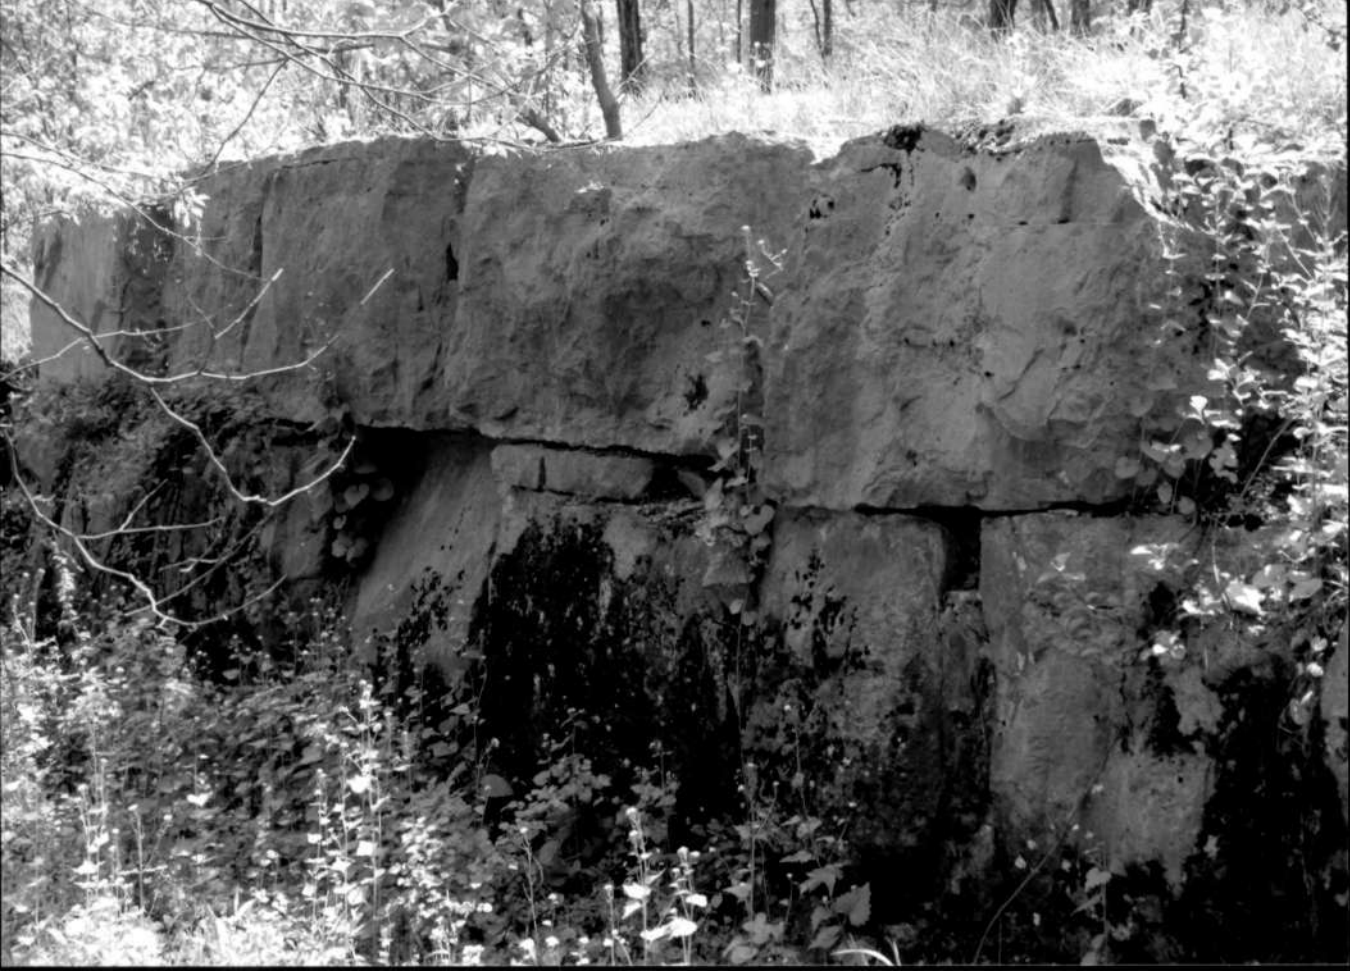
3 of 6

HO-1095_2012-04-24_03
Retaining wall, detail

Retaining wall, detail

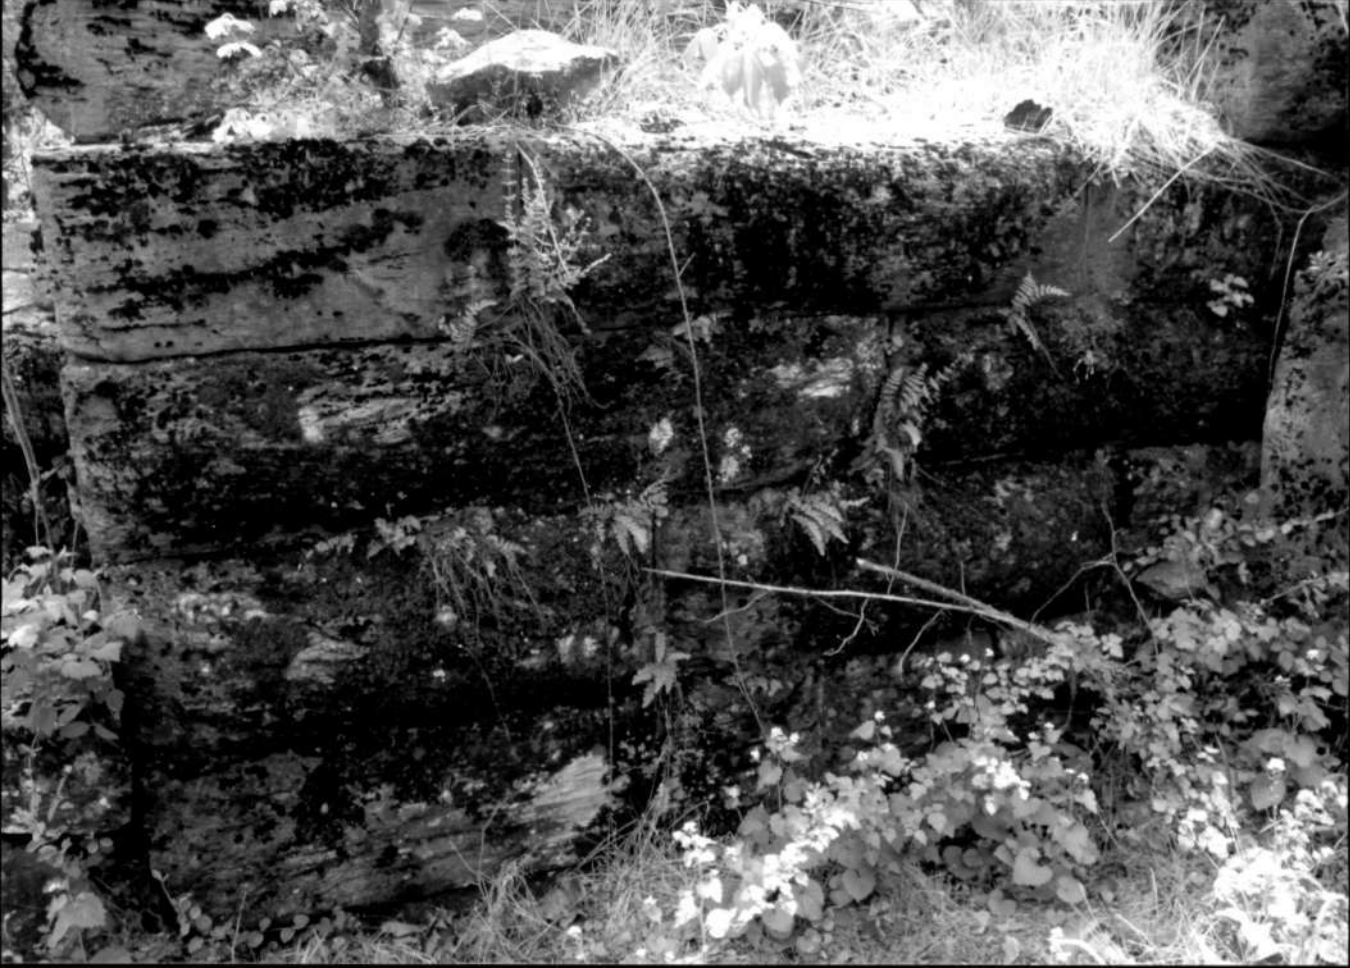
4 of 6

HO-1095_2012-04-24_04
Retaining wall, southeast wing wall

Retaining wall, southeast wing wall

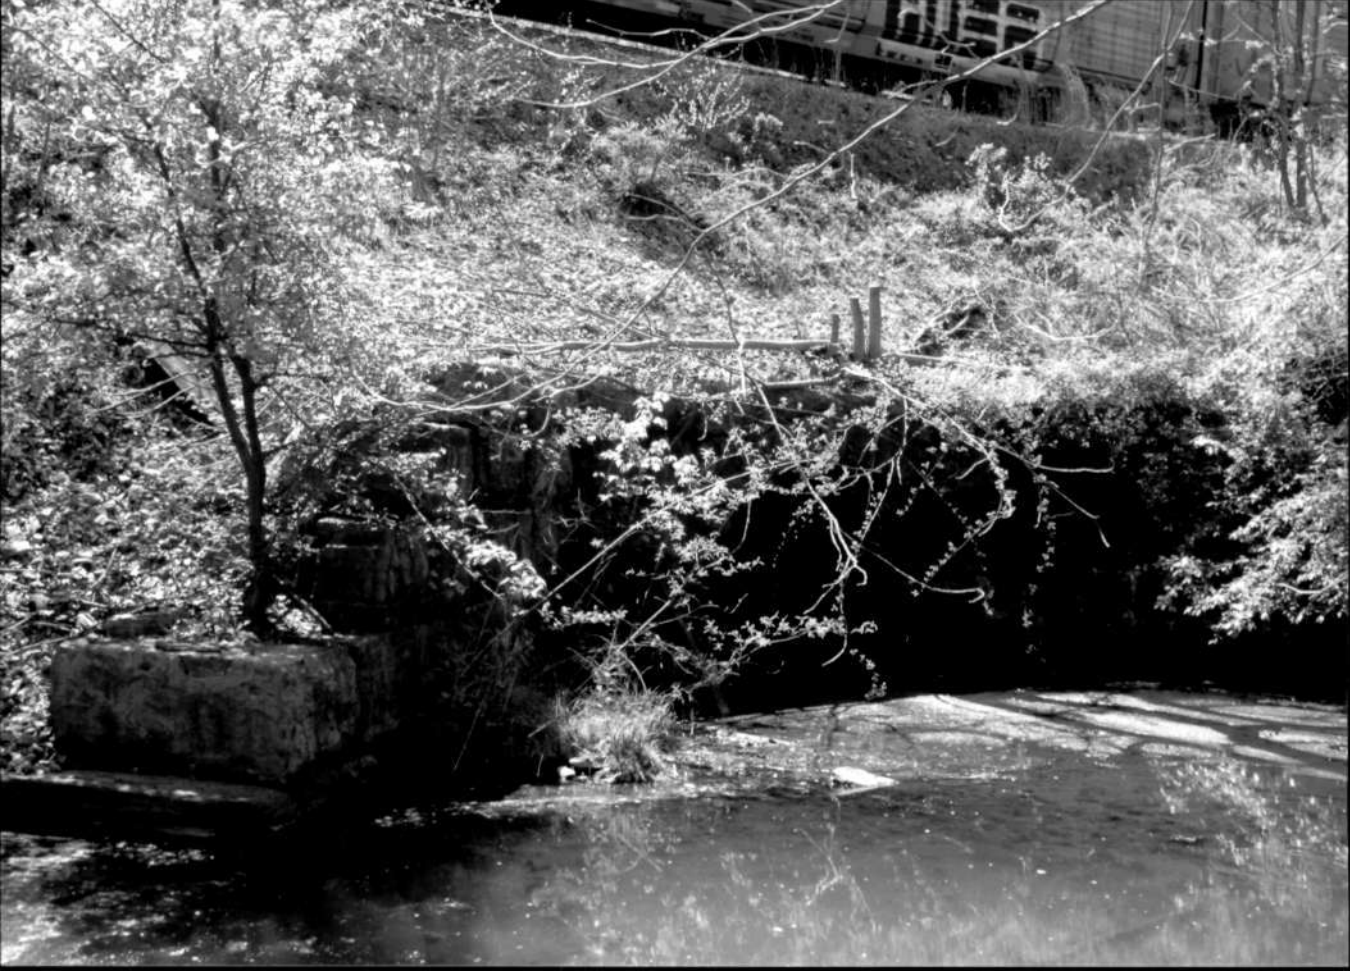
5 of 6

Near the southeast end of the realignment is a stone culvert for one of the streams, built of rock-faced granite ashlar, with wing walls that angle away from the embankment and step down. The top of the center wall is several large stones that have a rounded front face and are set slightly proud of the wall. There is a brick barrel vault, with stone voussoirs.

HO-1095_2012-04-24_05
Culvert, northeast side

Culvert, northeast side

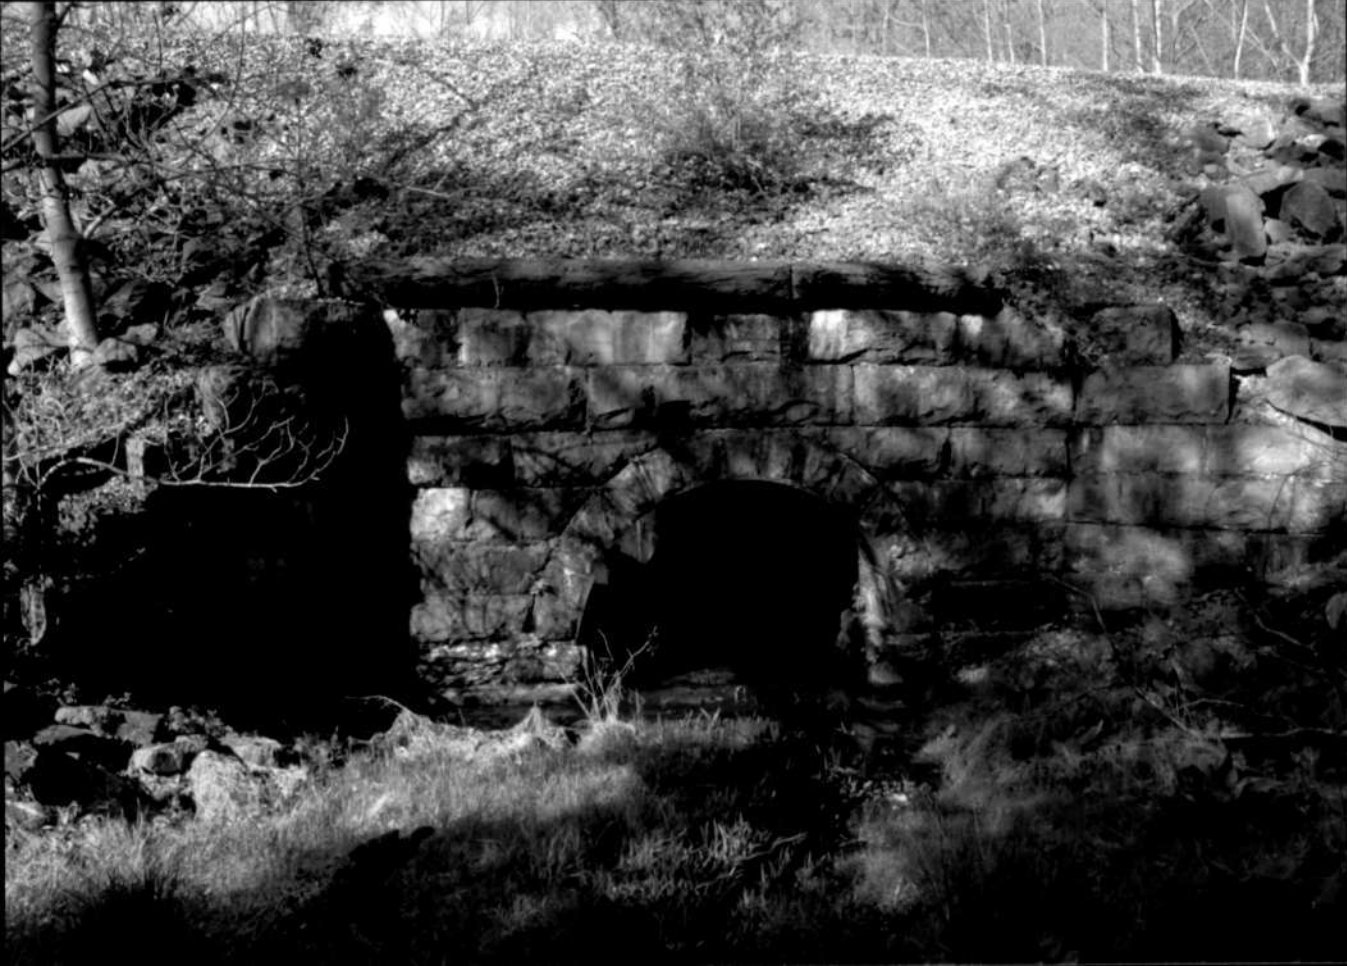
6 of 6

HO-1095_2012-04-24_06
Culvert, southwest side

Culvert, southwest side
